HT 365

Preservation Coating

Case History for Outdoor Storage

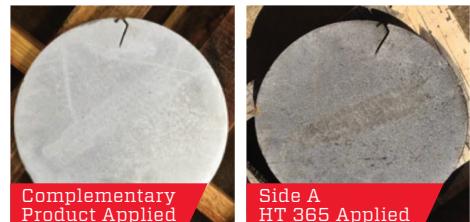
Application Date: 02/26/15 Observation Date: 05/01/15

HT 365 was applied to Side "A" and its entire edge and Side "B" was left untreated. Sample was stored outside in an uncovered area on a wooden pallet on its edge to expose both sides. After 63 days, Side "A" was observed for the first time and did not show any signs of rust after being treated with HT 365.

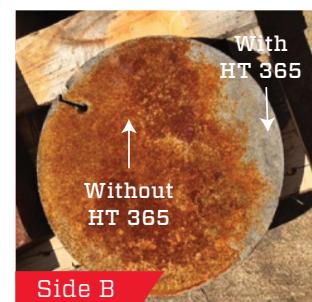
Side A: 90 Days

After 90 days, Side "A" was observed for the second time and had just begun to show signs of rust bloom. It is estimated on the basis of the light corrosion that was observed that HT 365 began to lose its effectiveness after 80 to 85 days. During the months of March and April, temperatures ranged from 35 to 90 degrees Fahrenheit. Several heavy rain storms were documented during the month of April, 2015. The entire edge of Side "A" that was also treated with HT 365 remained rust free. Now, if the Customer needs to remove HT 365 for any reason, they may do so by pressure washing the metal with HoldTight 102 diluted at 100: 1 water to HoldTight 102, rather than costly hand cleaning, as required by their current product in use.

On Side "B" that was not treated with HT 365, heavy rusting occurred. The applicator had started to paint this side with HT 365 before being stopped (so that there would be a control side). The area where HT 365 had been applied can be seen on the bottom sliver of the plate where it is rust-free, the rest of that side is heavily corroded.

After almost three months in outdoor storage exposed to extreme temperature swings, UV and extreme rain events, all surfaces coated with HT 365 were rust-free. This result preserves the sample for future use without the need for expensive rust and/or coating removal techniques. At the time that the piece of steel needs to be coating it should be power washed clean using HoldTight 102 and potable water.
